# Geology

Mountain Fire BAER  
(San Bernardino NF)

August 1, 2013

Jerome V. DeGraff, Sierra NF

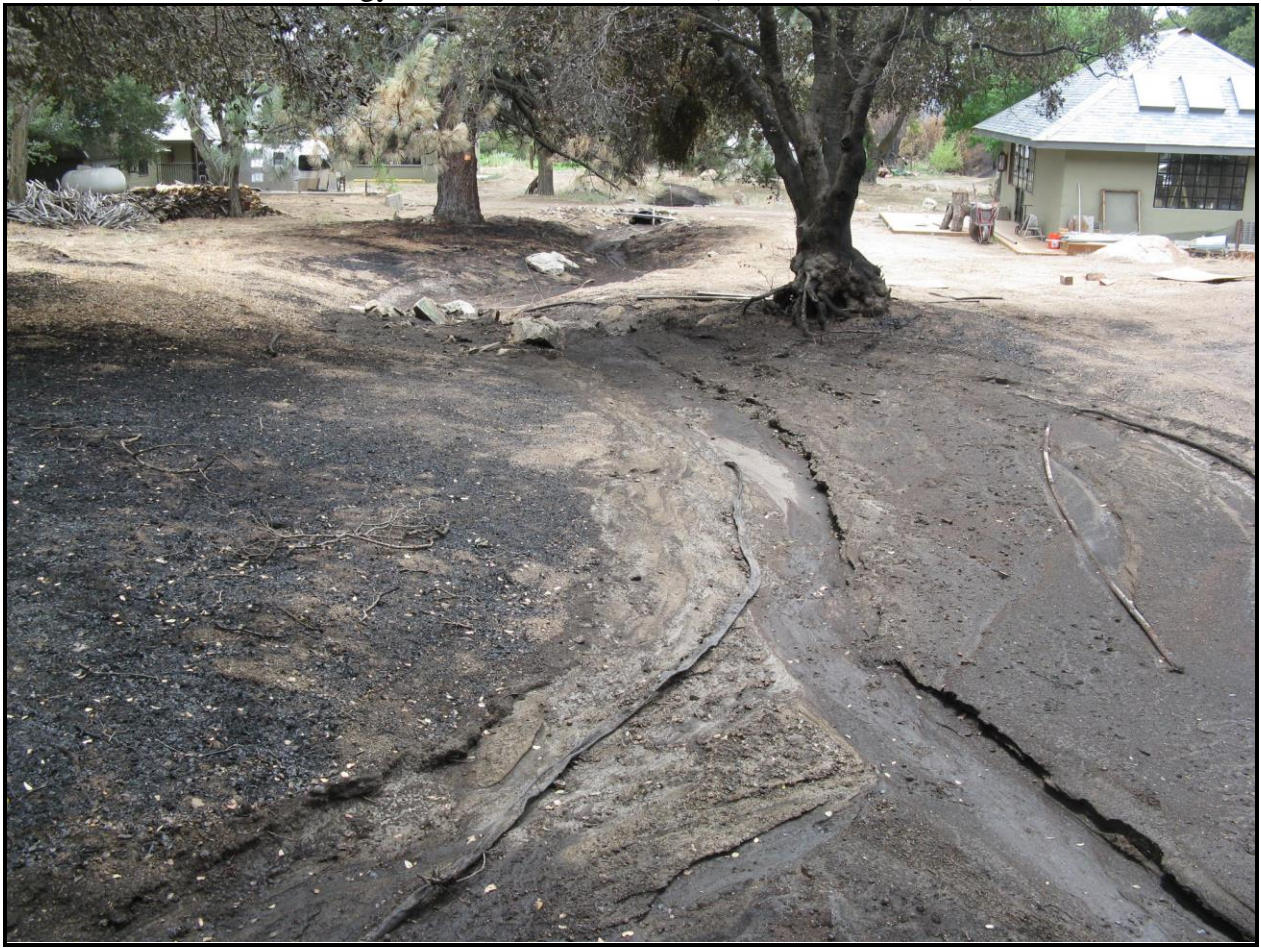
Figure 14. Muddy deposits from water flow through the Fobes Ranch. This view is towards downstream direction.

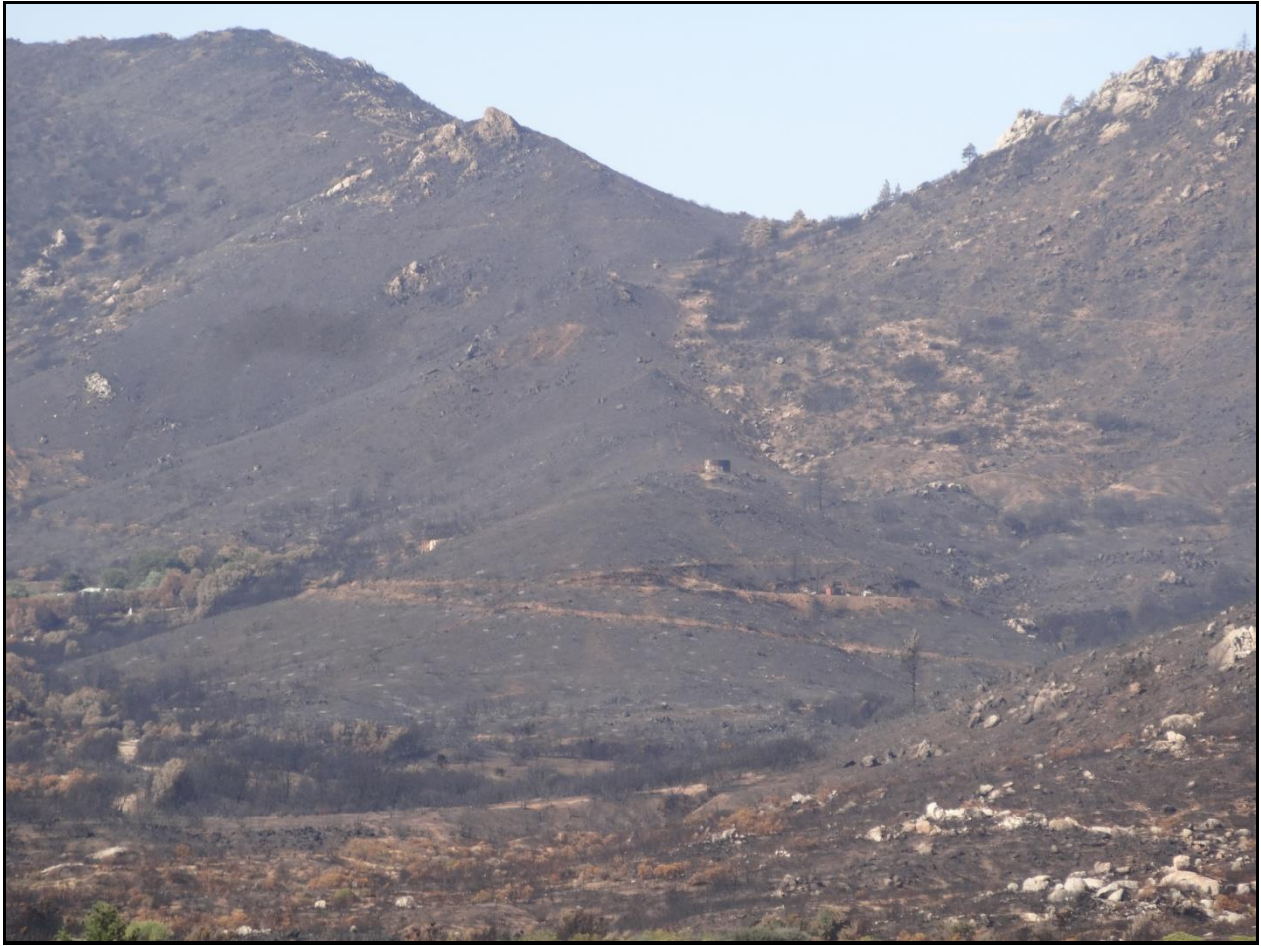
flow that was observed in the channel downstream is from the main drainage which passes just to the east of the ranch buildings (Fig. 15).

Figure 15. A photo to the northwest across the Fobes Ranch (left foreground). The trees passing from the lower left corner to the right of this view is the main stream channel. Notice the absence of visible rilling on the the slopes at the head of Fobes Canyon in this photo and in figure 10.

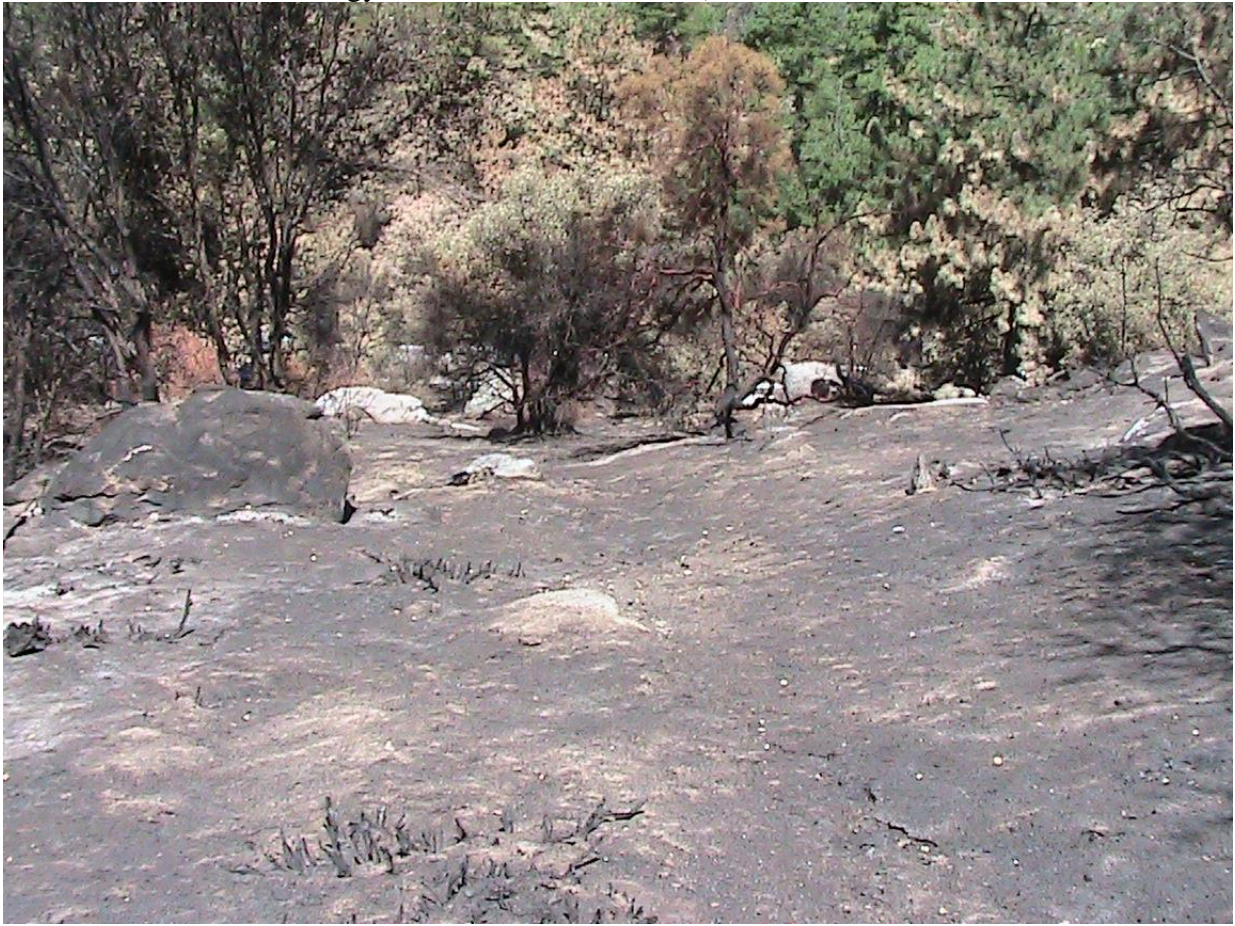
The area of concern can be divided into three slope units with differing rockfall risk potential. The first area is the northernmost moderately burned area extending to Highway 243 from the junction of Forest Road 5S01 and a trail on the former 5S03 road bed (Fig. 2). This is a planar slope with rock outcrops at the top and large to medium-sized boulders scattered down the slope. A few burned bushes are present, too. The slope averages 45% to the road. The cutslope at the toe averages 6 feet in height at an estimated 80% to the road shoulder. No rocks or dry ravel were present to suggest that rocks have moved down the slope to the road.

Figure 2. View down slope along the northern planar section. Highway 243 is just barely visible just left of center in the background.

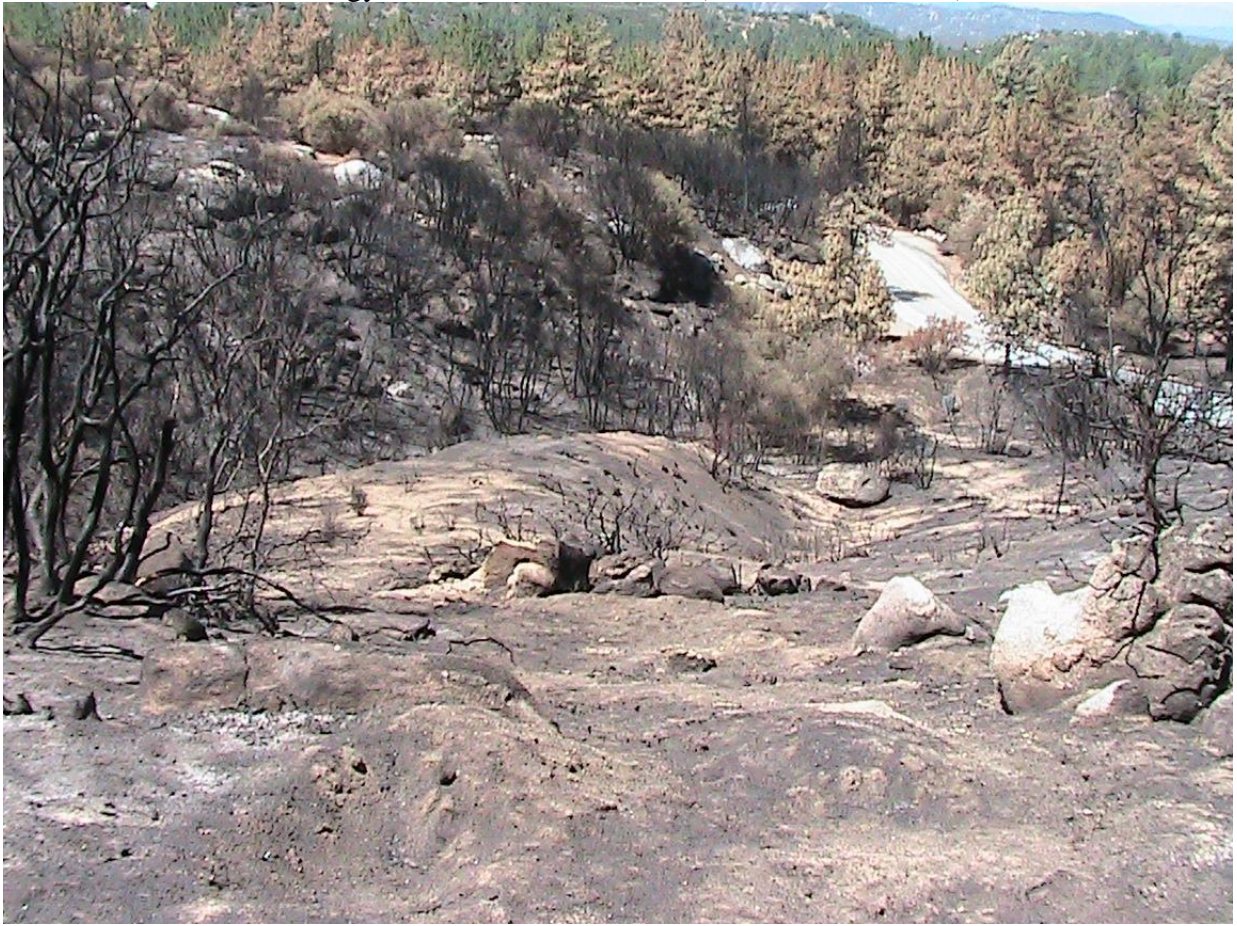
The second and largest part of the area is characterized by two steep-sided and deeply incised swales. Rocks are scattered on the swale slopes. The swales end at a snorkel inlet to the culvert draining this area (Fig. 3). The swale bottoms grade to an average of 45%. There is a 15 by 6-foot basin around the inlet with the long dimension being parallel to the road alignment. The basin side closest to the road is 6-foot deep and nearly vertical. Dry ravel and displaced rocks were not seen in this basin to suggest movement of rocks had occurred since the fire passed through.

Figure 3. The large area in the middle of the moderately burned slope. Highway 243 is seen along the right-hand side of this view. Note the vertical snorkel pipe at the toe of the swale.

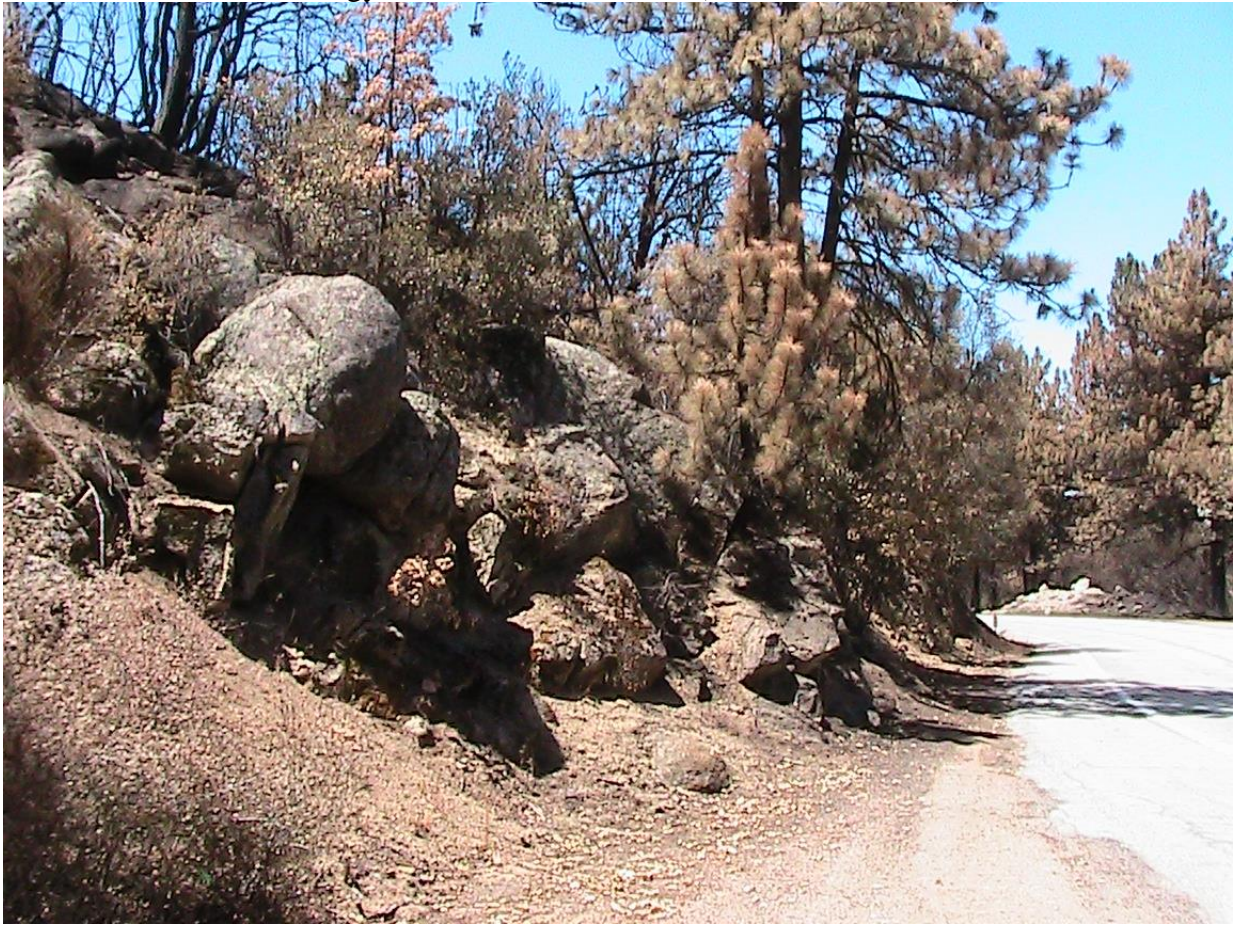
The third part of the area is the one on the south. It is a relatively flat slope from Forest Road 5S01 to near Highway 243. The end of the flat ends with exposed jointed, granitic bedrock. From the top of the bedrock to the road shoulder is about 10-feet high and inclined nearly vertically (Fig. 4). Some dry ravel (a thin layer over ash-covered soil) and a few rocks up to 3-inches in diameter are present suggesting some movement of material down the steep face (Fig. 5). This high cutslope grades to a minor cutslope with some scattered rock on a 20% slope which ends at the driveway to Keenwild Fire Station (and its mailbox).

Figure 4 The third segment of slope evaluated showing the steep cutslope with exposed bedrock.

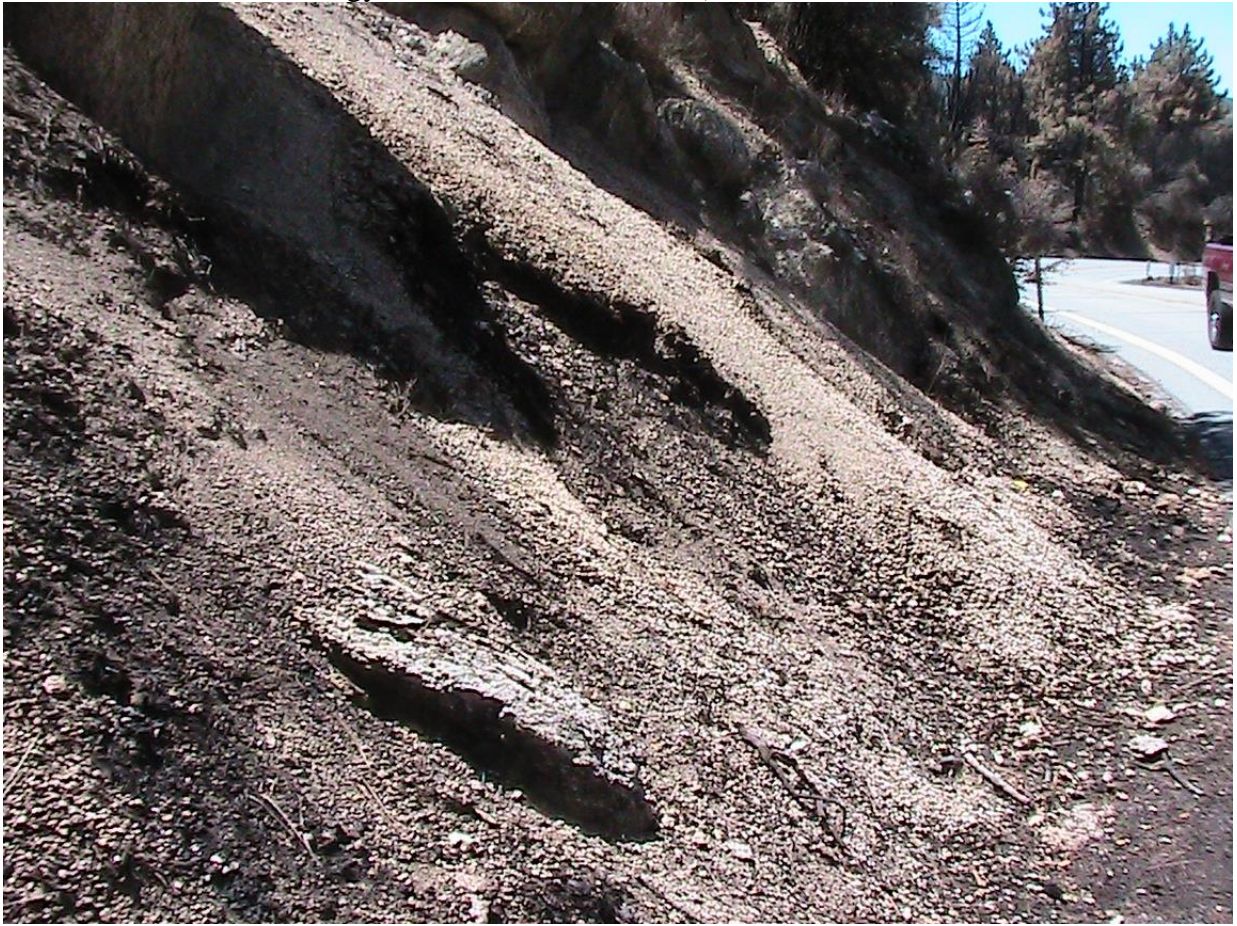
Usually, rock movement and dry ravel occur as the fire passes over the area and shortly afterwards. The absence of this evidence of movement adjacent to Highway 243 suggests little rockfall has occurred. This may change during future storm events. The movement of individual rocks into the road bed is the most likely rockfall event in the future. While this seems a low likelihood event, given the evidence to date, it only takes a single rock being unexpectedly struck by a motorist or motorcyclist failing to see it in time.

Figure 5. Minor dry ravel and small rocks at base of rock outcrop in cutslope along Highway 243.

Value-at-Risk	Objective	Description	Cost
1. State Highway 243 north of Keenwild Fire Station	Protect life and property	No effective NFS land treatment due to site conditions and low probability of occurrence	<b>No cost to govt.:</b> make an official notification to the California Department of Transportation District responsible for this highway segment that rockfall is possible and their regulations may require signs or other actions.
2. Debris flow hazard to upper Apple Creek (Zen Center/Bonita Vista Ranch)	Protect life and property	No NFS land treatment; onsite actions would be effective	<b>No cost to govt.:</b> make notification of hazard to landowners; share risk information with NRCS, OES and other emergency service organizations; ensure NOAA coordination for storm warning notices; evaluate whether additional RAWS stations on NFS land might improve warning forecasts.
